Subject: Global Alternative Method of Compliance (AMOC) request for Airworthiness Directive (AD) 2012-10-11, Docket No. FAA-2012-0324; Directorate Identifier 2012-CE-008-AD for the Burkhart GROB Luft- und Raumfahrt GmbH Model G 109 and G 109B Powered Sailplanes.

ATTACHMENT 1

Global AMOC - Alternative Inspection Method

AD 2012-10-11, Paragraphs (f)(1)(ii) and (f)(1)(iii)

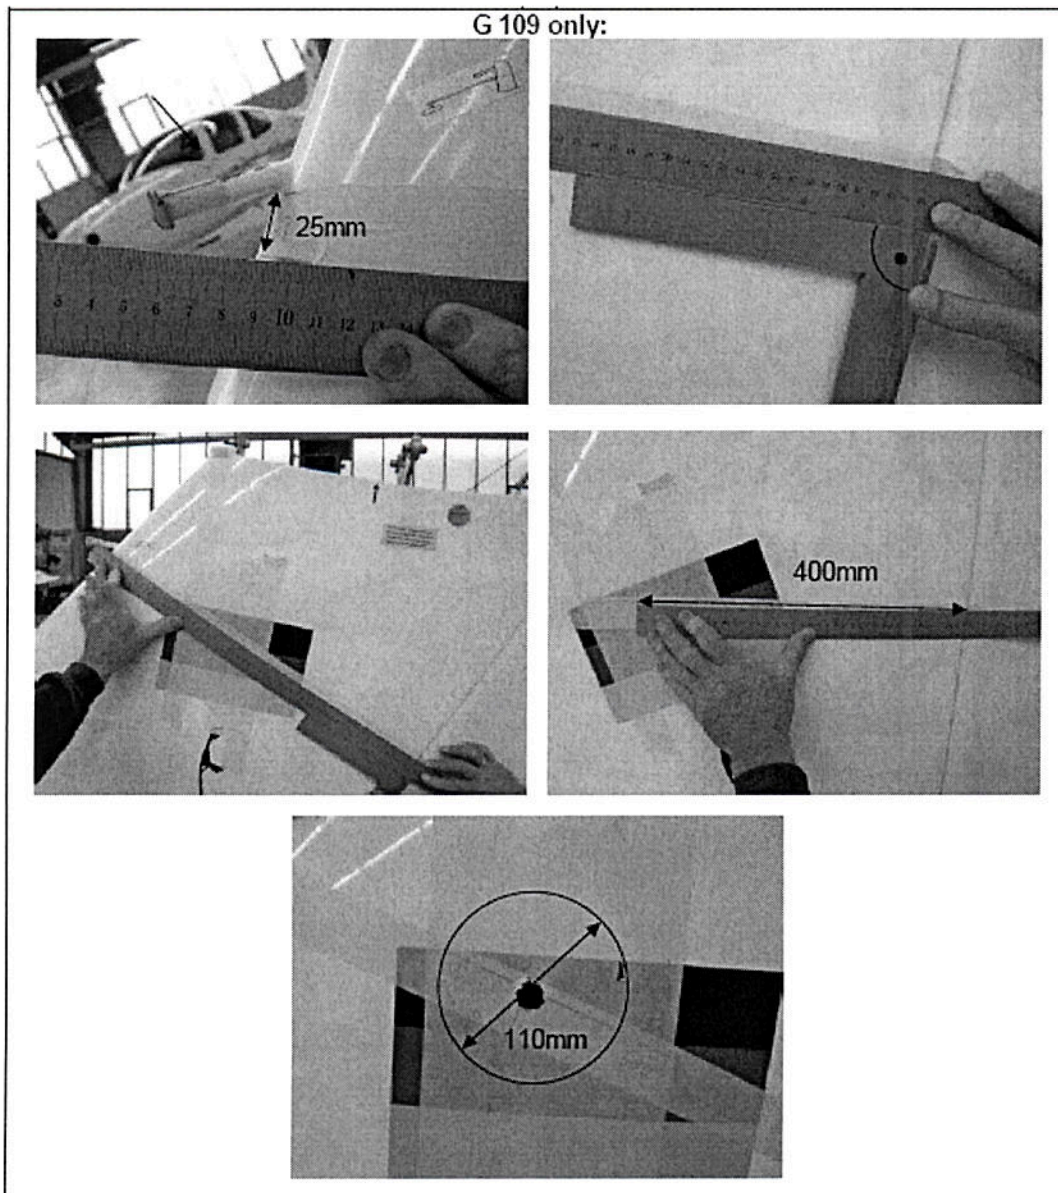
Picture 1 – G 109 110 mm Opening Location

1. Make a 16 mm diameter hole anywhere within the boundary of the 110 mm inspection opening defined in Grob Aircraft Repair Instruction Doc. No. RI 817-010/1, issue date December 20, 2011, as specified in Grob Aircraft Service Bulletin MSB817-60, dated November 24, 2011. Picture 1 shows the layout of the 110 mm opening on the model G 109. Picture 2 shows the layout of the 110 mm opening on the model G 109 B. Picture 3 shows a typical example of the 16 mm hole placement.
