**Subject:** Inspection and replacement of spar spigot assemblies

**Concerning:** Model: ASTIR CS TCDS No.: 306  
 - Series: - S/N:  
 ASTIR CS 1001-1536  
 ASTIR CS 77 1601-1844  
 ASTIR CS Jeans 2001-2248  
 CLUB ASTIR II 5001-5061 (Suffix "C")  
 STANDARD ASTIR II 5001-5061 (Suffix "S")  
 G 102 CLUB ASTIR III 5501 & up (Suffix "C")  
 G 102 CLUB ASTIR IIIB 5501 & up (Suffix "Cb")  
 G 102 STANDARD ASTIR III 5502 & up (Suffix "S")

Model: SPEED ASTIR II TCDS No.: 320  
 - Series: - S/N:  
 SPEED ASTIR II 4001-4027  
 SPEED ASTIR IIB 4028-4107

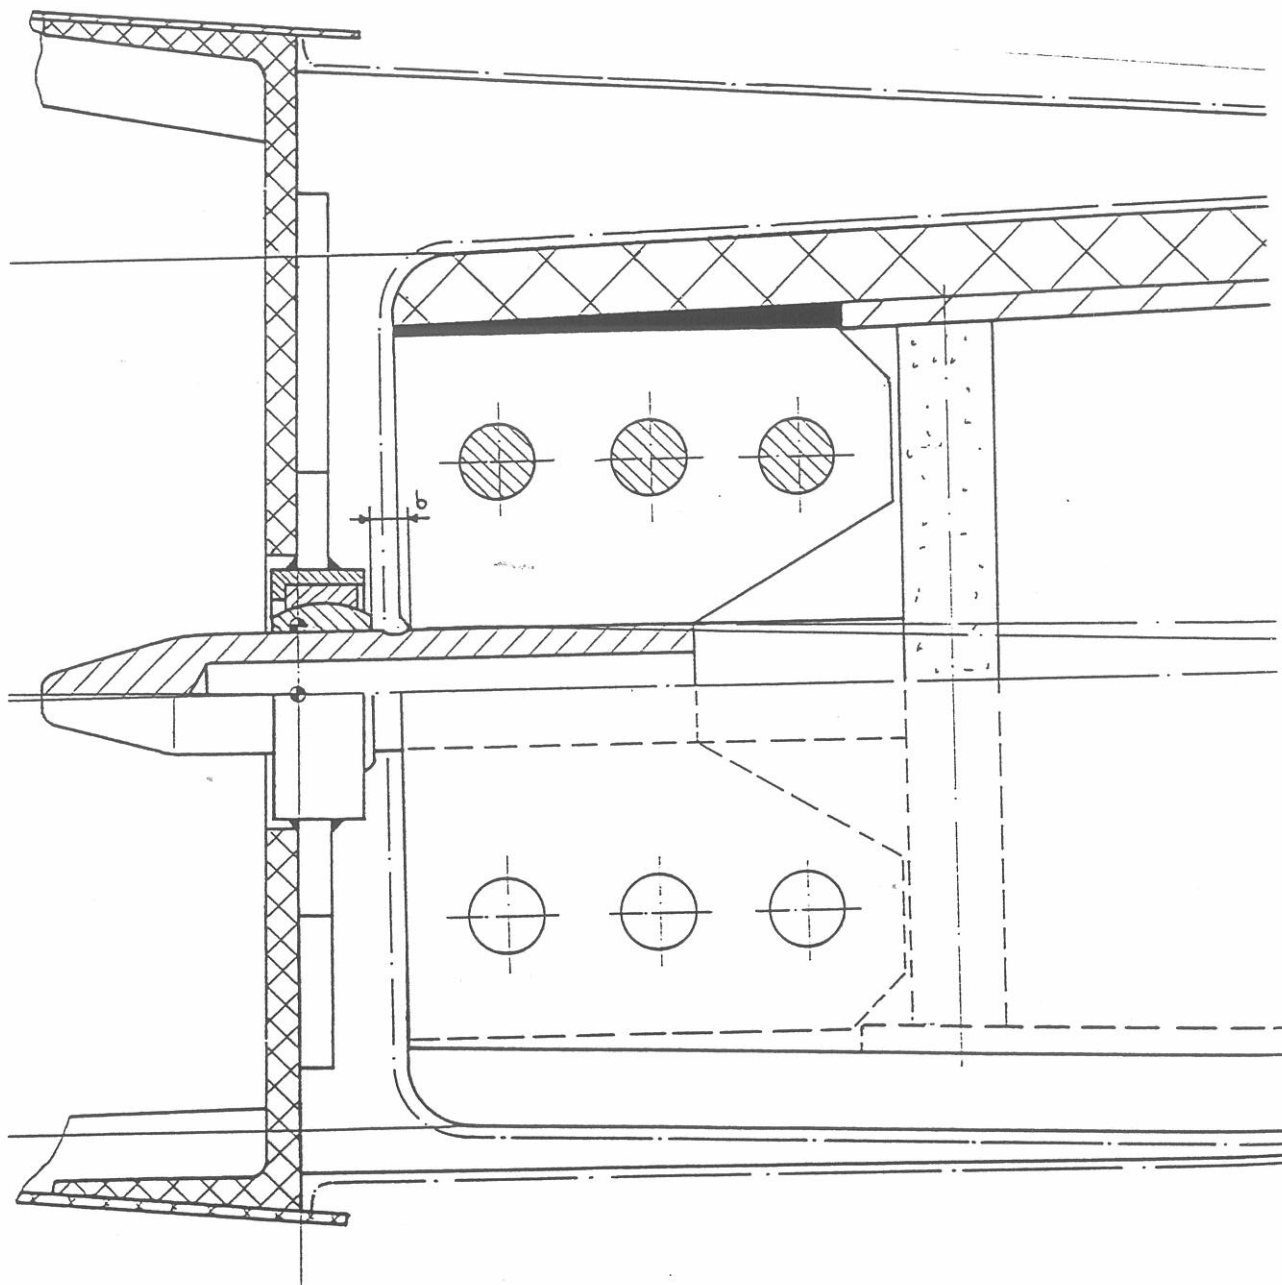
Definition of the distance  $b$

If no crack is discovered and if the distance between spigot plates and swivel bearing is (refer to figure on page 3):

- $b \leq 10 \text{ mm}$ : Carry out Action 2 not later than 31 December 1992
- $b > 10 \text{ mm}$ : Carry out Action 2 not later than 30 June 1991

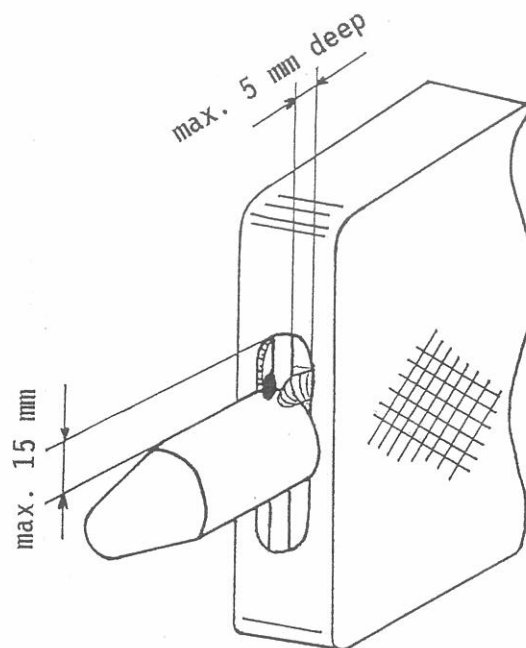
To perform the crack inspection the section of the wrapping around the main spigot has to be removed (max. 15 mm) and the adhesive material removed to expose the welding seam (max. 5 mm deep, see figure). Be very careful not to scratch or otherwise damage the spigot or plate.

If the weld seam is continuous around the plate, the complete toe of the welding seam has to be inspected. Grooves or nicks in the surface of the welding seam which are not part of a crack must be polished out and the crack inspection performed again.

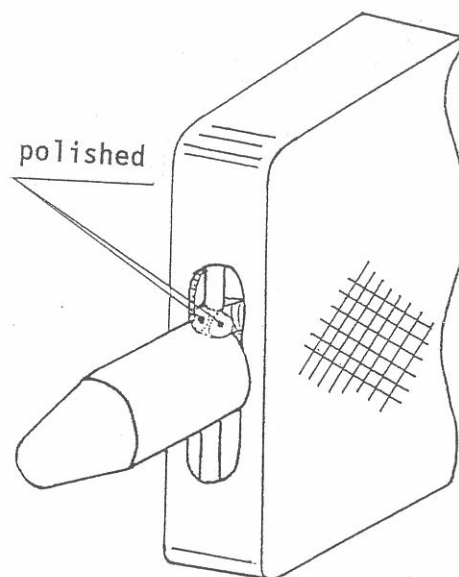
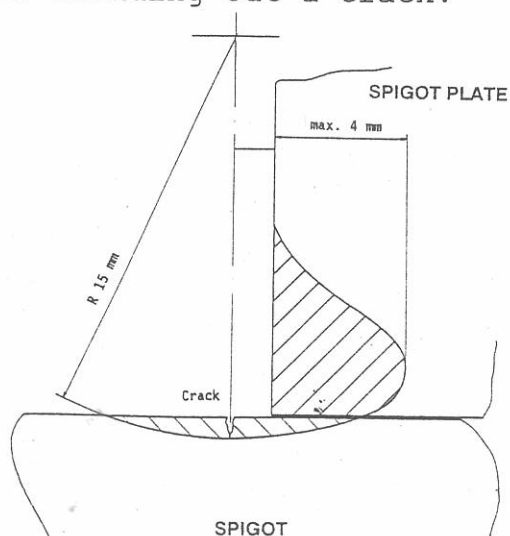
A crack may be blended out if the following conditions are fulfilled:

- \* crack on one side not deeper than 0.75 mm
- \* cracks on both sides not deeper than 0.5 mm each

Blending out should be done with grinding caps or equivalent. The grinded surface has to be polished.

Sketch mentioned below shows a cross section of blending out a crack.

Finally apply a coating of resin to the exposed area (wood and metal).
