MANDATORY BULLETIN

MB No.: L23/053a

Concerns: All L23 Super-Blanik sailplanes.

Subject: Inspection of welded bracket (Drwg. No. A730 420N) located on the fin.

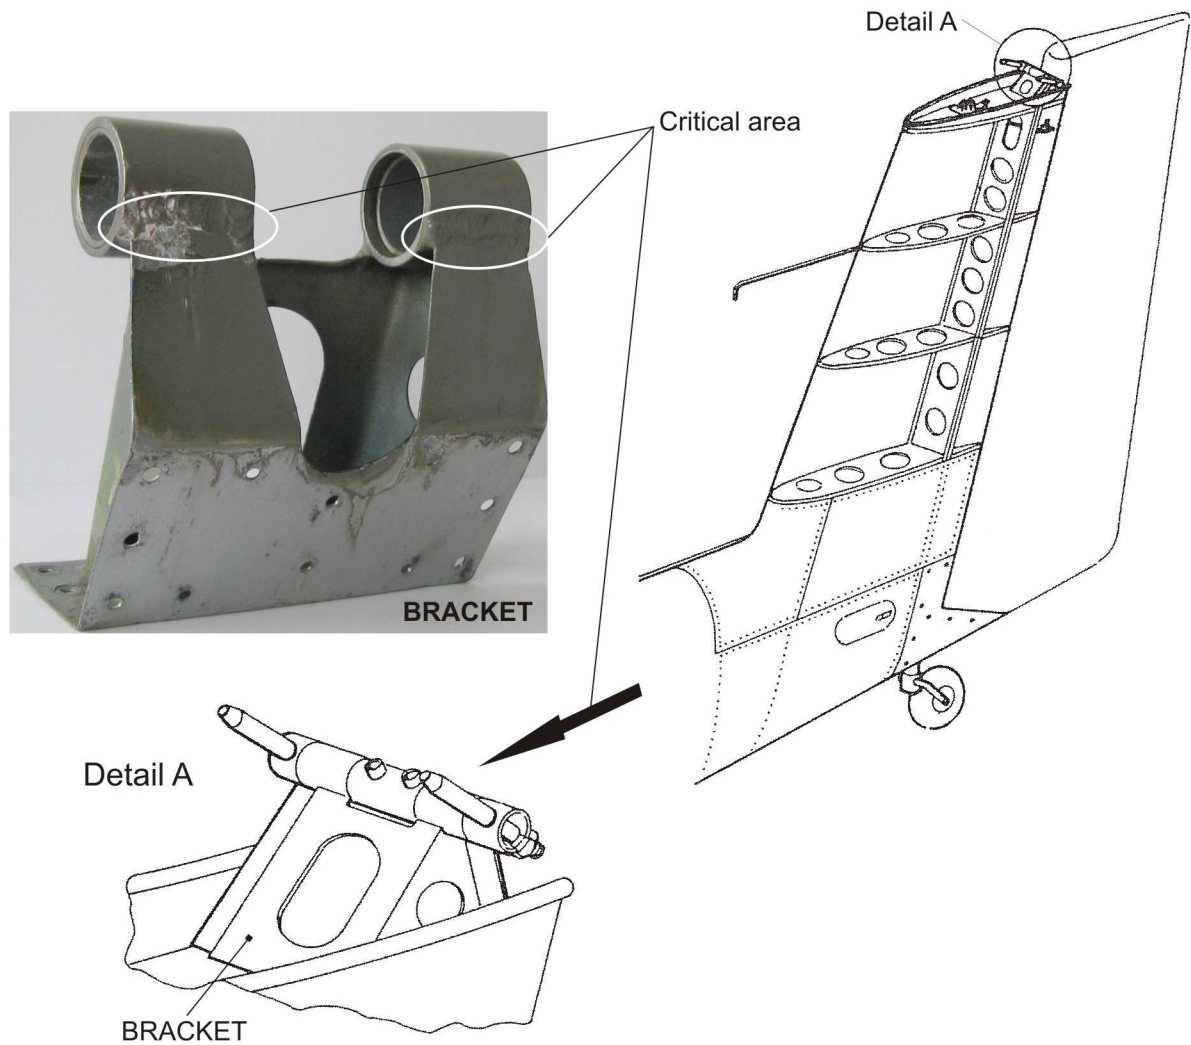
C. ILLUSTRATED PART

Reason: Appearance of cracks on the bracket.

- Checked area: weld in sleeves areas with special focus to the critical areas marked on the figure in part C of this bulletin.
- Perform the check by means of magnifier (6 times magnifying).
- Admissibility criteria: No cracks in checked area of the bracket are admissible.
- If no cracks are present on the checked bracket, perform record in the Airframe Logbook according to the part I.
- If cracks has been detected on the checked bracket, the sailplane further operation is prohibited. Perform replacement of the damaged bracket according to the IB L23/054b.

In case of cracks detection, send the bracket to the sailplane producer together with basic data of the sailplane (registration mark, S/N, total flight hours and number of take-offs since the sailplane has been put into the operation).
