## SERVICE BULLETIN

N° 25/53/03

**SCOPE :** REAR AND FORWARD SUPPORTS OF BOTH HORIZONTAL STABILIZER MODIFICATION.

**Affected models:** PIPER "Pawnee" PA 25; PA 25-235 y PA 25-260;  
CHINCUL "Pawnee" PA 25; PA 25-235 y PA 25-260;  
LAVIA "Puelche" PA 25-235 y PA 25-260.

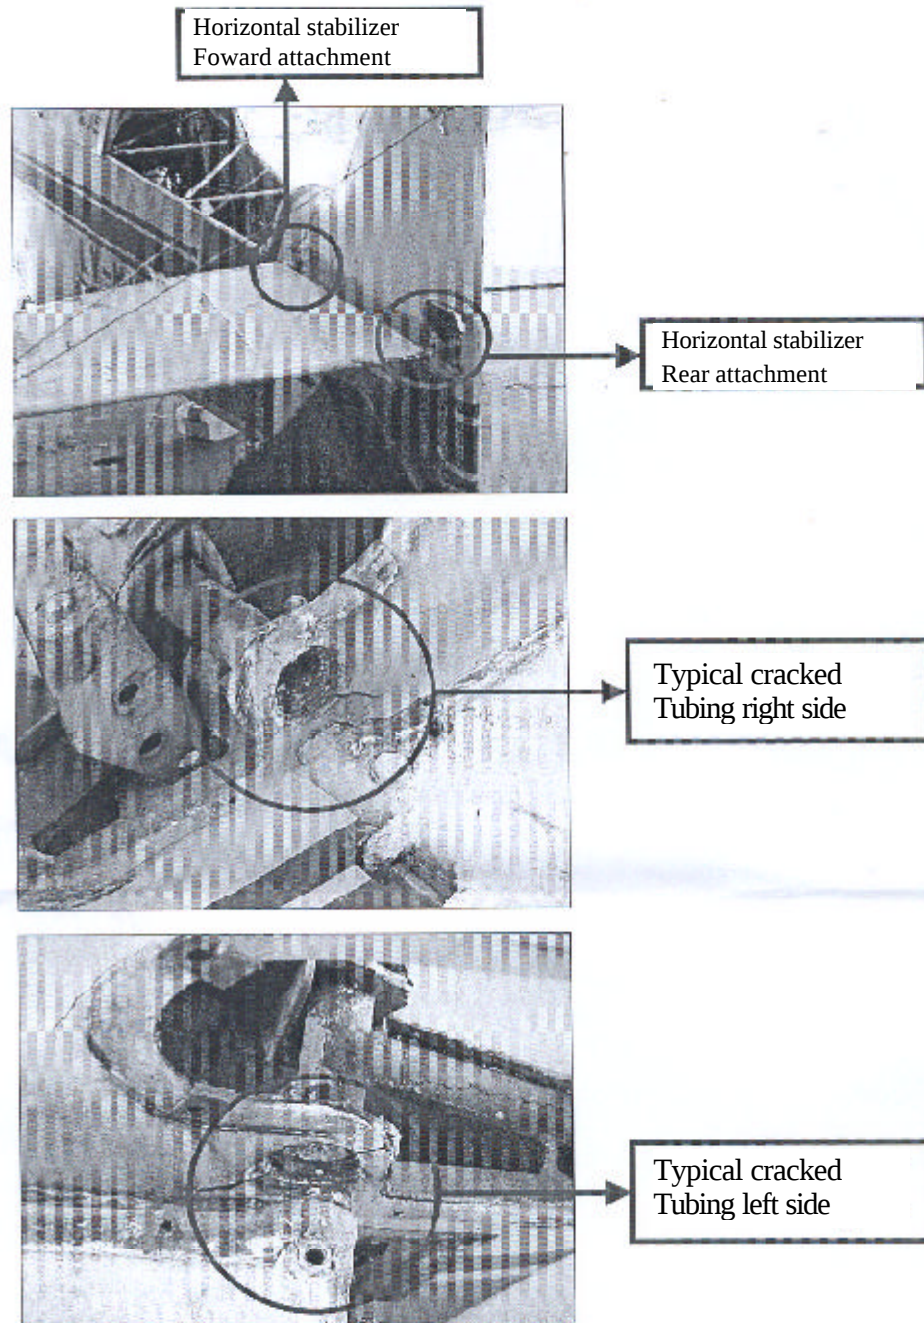
FIGURE 1

**BACKGROUND:** It have been found on several of the affected airplanes some severe corrosion and cracks in both supports. The probable cause for those failures is the accumulation of steam or application products vapors. The Dirección Nacional de Aeronavegabilidad through the Dirección de Aviación General issued the ADVERTENCIA: 035/DAG, dated 29 Jun 2004 advising to the aeronautical community about this risk situation. The affected airplanes were those with an accumulated time in service of 2000 flight hours (F.H.) average, approximately.

- 1.- This actions must be repeated up to the DEFINITIVE ACTION application.
- 2.- If some irregularities as those pointed out in the upper part of this S.B. are detected, the repair shop performing the 50 F.H. inspection must go to a deeper inspection including disassembling and check both supports. See Figure 1 to locate possible damaged areas in the supports.
- 3.- If some of the anomalies described in NOTE 2 are detected DEFINITIVE ACTION must be apply.

**DEFINITIVE:** Disassembly both stabilizer surfaces (See Manual de Mantenimiento PUELCHE for details related to this disassembly). Remove fabric in the areas of both supports) , to gain access, this remotion must provide enough room to operate adequately. Once you get the corresponding room, proceed to remove both support and destroy them, use an adequate grinder to eliminate the remaining pieces of both supports.

After performing the previous operation, install new parts of Kit ( Forward support P/N K-002 D, and rear support P/N K-002 T), taking into account the correct alignment of the supporting tubes. Weld both supports by using a T.I.G. machine and perform a continuous weld bead all along the contact area. After completing the welding process verify again the correct position and alignment of the supports. Clean the area and protect with zinc chromate painting.
