## SERVICE BULLETIN

N° 101-29

SN CENTRAIR GLIDERS  
101 all types "Pégase"

**SUBJECT:**VERIFICATION OF SETTING OF RUDDER BAR LOCKING  
ADJUSTMENT TUBE**VALIDITY:**

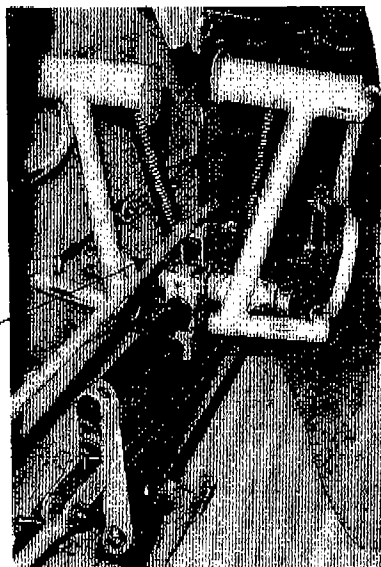
The adjustment system of the rudder bar  
comprises a tube attached to a tipper with  
which the rudder bar can be unlocked and  
adjusted remotely in relation to the pilot's  
seat back. (See photo no. 1)

Rudder bar locking  
adjustment tube

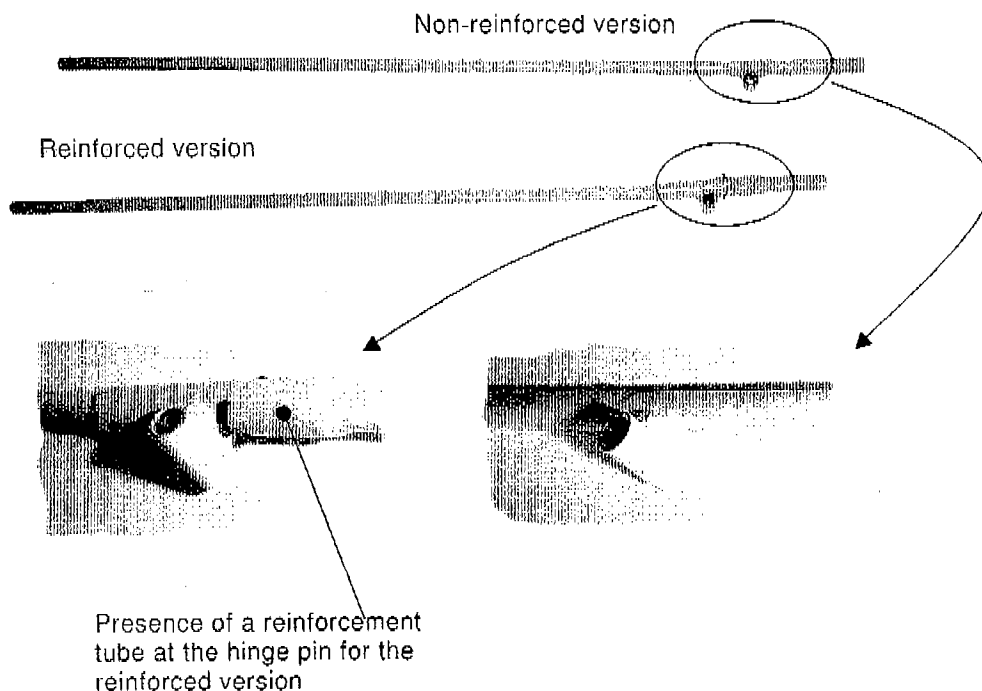
Photo no. 2

This locking tube was reinforced in 1984 to avoid any concerns over operation. Gliders  
manufactured prior to this adaptation have not been systematically retrofitted.

The differences between the 2 versions are shown in photo no. 2 below.

Having recently been informed of one of the old versions of this locking tube breaking, it is therefore confirmed that the reinforcement of this part was justified and the systematic replacement of non-reinforced parts is now necessary.

It is therefore requested, within 1 month, that you check the adjustment tube version installed in your glider (visual examination without dismantling the part from the glider).

If you see that you have the reinforced tube (see photo no. 2), you do not need to take any further action.

If, however, you see that you have the non-reinforced version (see photo no. 2), you are requested to replace it with a part ref. \$Y186A before the next annual visit.

If the locking tube is damaged, it must be replaced before the next flight.
